## Technical Report

# Enhancing Situational Awareness at Grade Crossings Using Machine Vision Technologies

Automotive and Surface Transportation  
National Research Council Canada

Project: A1-022649  
Report number: AST-2024-0035  
Version: 1.0

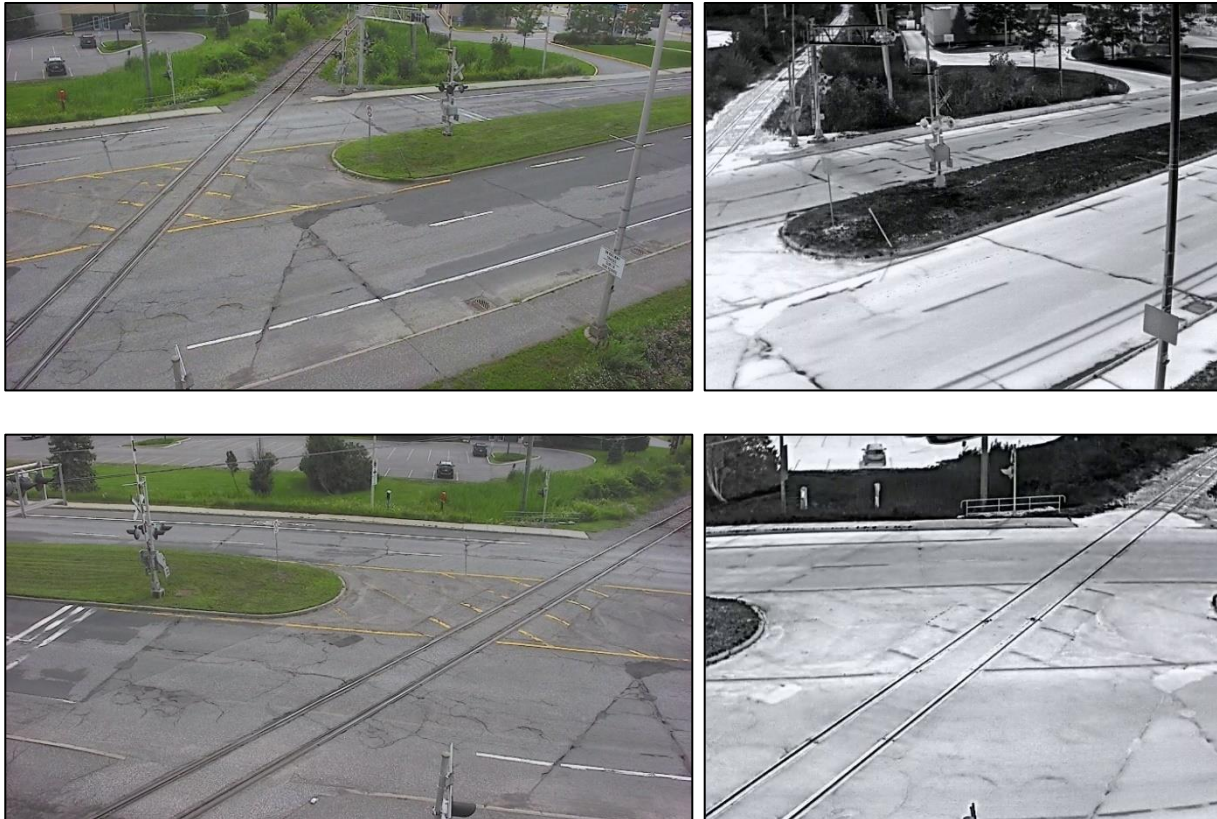
Figure 2: Ingress view of the crossing captured by RGB camera (top-left) and thermal camera (top-right); egress view of the crossing captured by RGB camera (bottom-left) and thermal camera (bottom-right). Northbound road traffic is in the far lanes and moves from right to left, and southbound road traffic is in the near lanes and moves from left to right.

The crossing's ingress and egress views were both captured using a variety of vision sensors, including RGB and thermal cameras, as illustrated in Figure 2. These cameras were mounted on roadside infrastructure west of the road. The ingress and egress camera views were based on a vehicle traveling north in the east lanes. However, the camera views were quite broad and provided good enough resolution to cover the ingress and egress for south-bound traffic in the west lanes too.

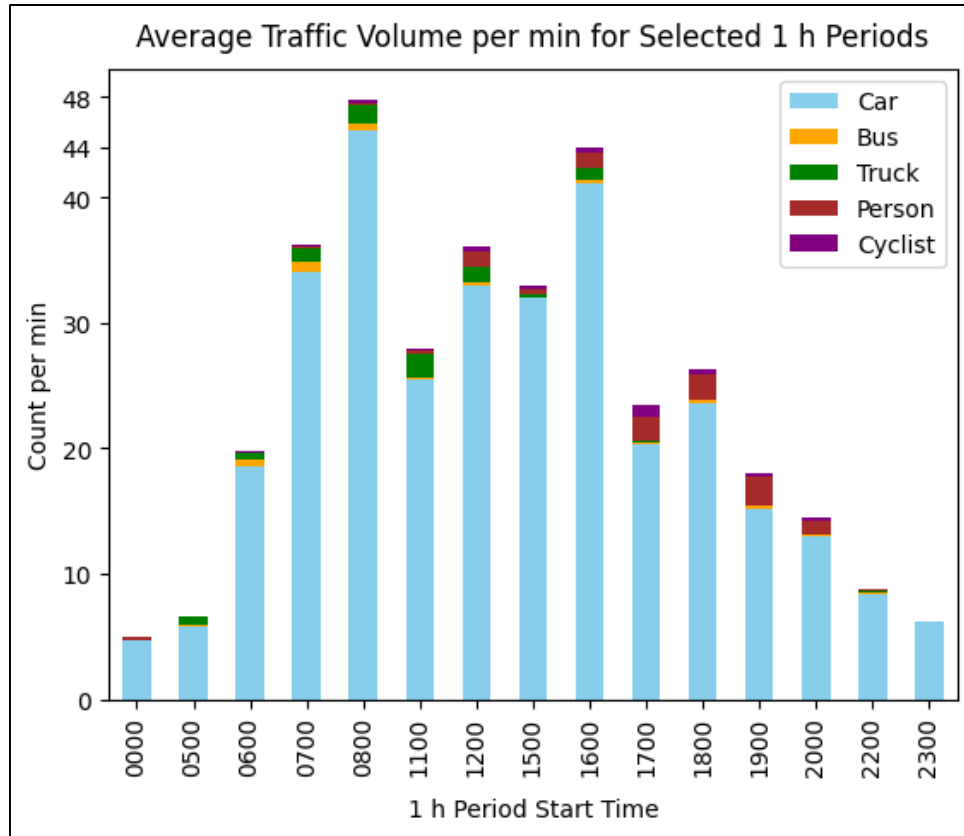
Figure 4: Average number of vehicles and VRUs passing through the crossing per min for selected 1 h periods of interest.

To understand the traffic patterns at the crossing, Figure 4 illustrates the average number of vehicles and VRUs passing through the crossing per min for 1 h, during the selected hours shown in the figure. The VRUs are separated into persons and cyclists. Rush hour commutes are notably in the 0700 hour (i.e., up to, but excluding 0800), the 0800 hour, 1200 hour, 1500 hour, 1600 hour, and 1700 hour, with the average traffic volume exceeding 30 vehicles/VRUs per min. Among these, the 0800 hour stands out with the highest traffic volume, averaging approximately 48 vehicles/VRUs per min, followed by the 1600 hour registering approximately 44 vehicles/VRUs per min on average.

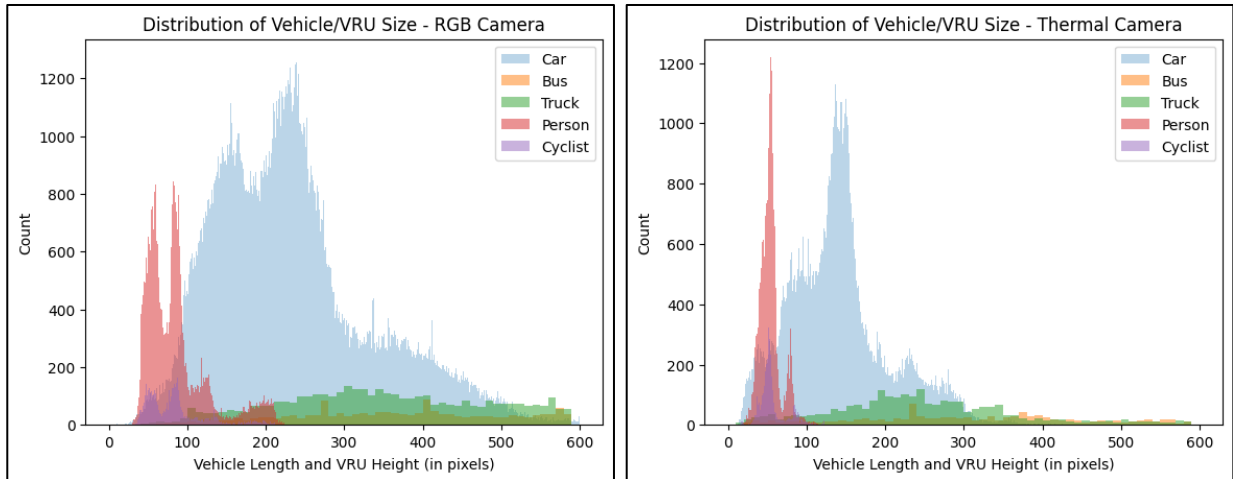
Figure 5: Distribution of vehicle and VRU sizes for PTZ cameras (left) and thermal cameras (right).

The left side of Figure 5 illustrates the length distributions (in pixels) of various vehicles and the height distributions (again in pixels) of different VRUs (again divided into persons and cyclists) observed by the PTZ cameras. On the right, the same distributions are depicted for the thermal cameras. VRUs, being shorter, dominate the lower tail of the distributions ranging from approximately 30 to 250 pixels for the PTZ cameras, and 18 to 120 pixels for the thermal cameras. On the other hand, buses and trucks, due to their larger sizes, occupy the higher tail of the distributions having a range of 120 to 1,890 pixels for the PTZ and 80 to 640 pixels for the thermal cameras. Cars exhibit wide variability in their lengths with the peak of the distribution between 150 to 250 pixels for the PTZ cameras and 100 to 150 pixels for the thermal cameras. Comparatively, in the thermal camera distributions, vehicles and VRUs appear smaller, which can be attributed to the lower resolution of thermal cameras compared to PTZ cameras as mentioned in Table 3.

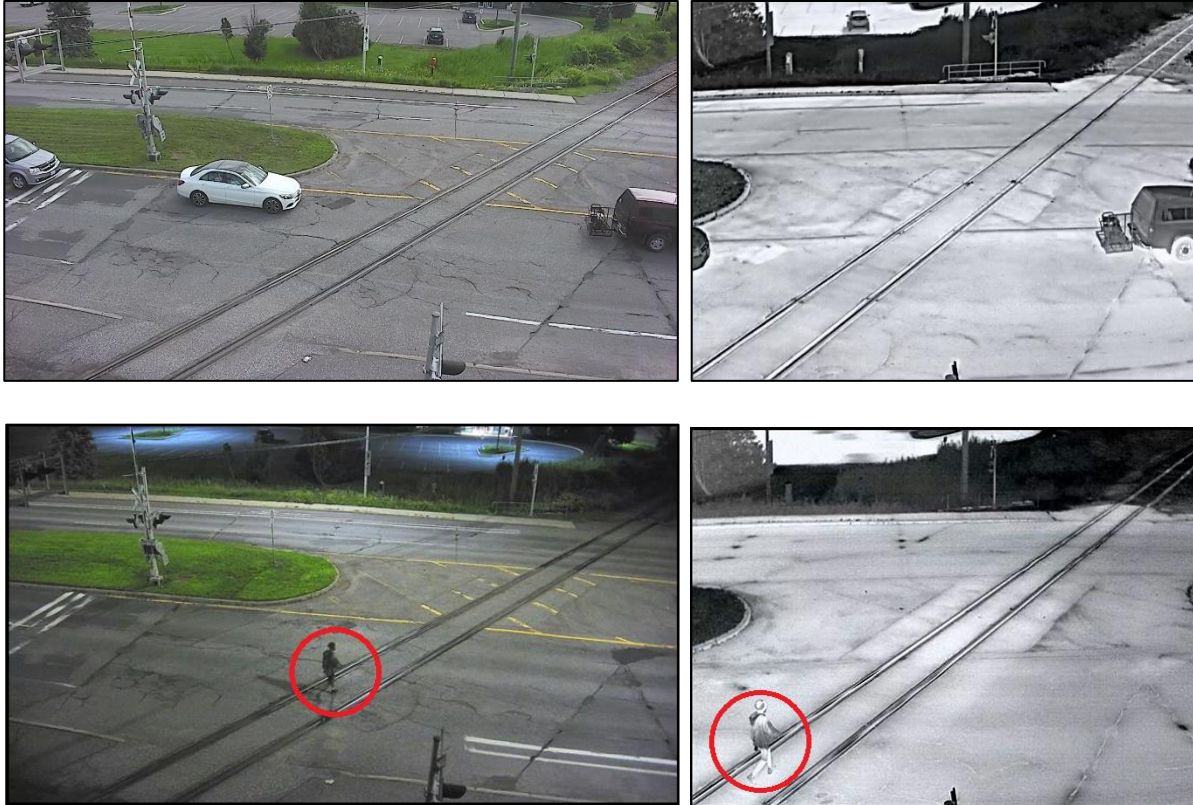
Figure 6: Examples of some of the potentially unsafe events captured by both PTZ and thermal cameras. The top row depicts a scenario where cars queue up on the egress of the crossing, extending past the crossing into the ingress area. The bottom row shows a pedestrian (encircled in red) intruding into the railway right of way.

In total, 5 instances of U-turn on the crossing, 29 instances of queuing, 1 instance of vehicle stopping on the crossing surface, 19 instances of vehicle stopping near the crossing, as well as 100 jaywalking and 35 intrusion events were captured in the dataset. Figure 6 shows two examples (top – queuing on the crossing; bottom – pedestrian intrusion into the railway right-of-way) of the six event types.

Among the different events involving vehicles, queue buildup on either ends of the crossing was observed the most in the collected dataset. This was particularly concerning, especially queuing on the egress as mentioned in section 2.3.3, due to the potentially dangerous situation this can lead to. For example, queuing on the egress can potentially trap vehicles between the gate arms for a prolonged time – an example is shown in the top row of Figure 6 – thereby increasing the chances of collision with a train.

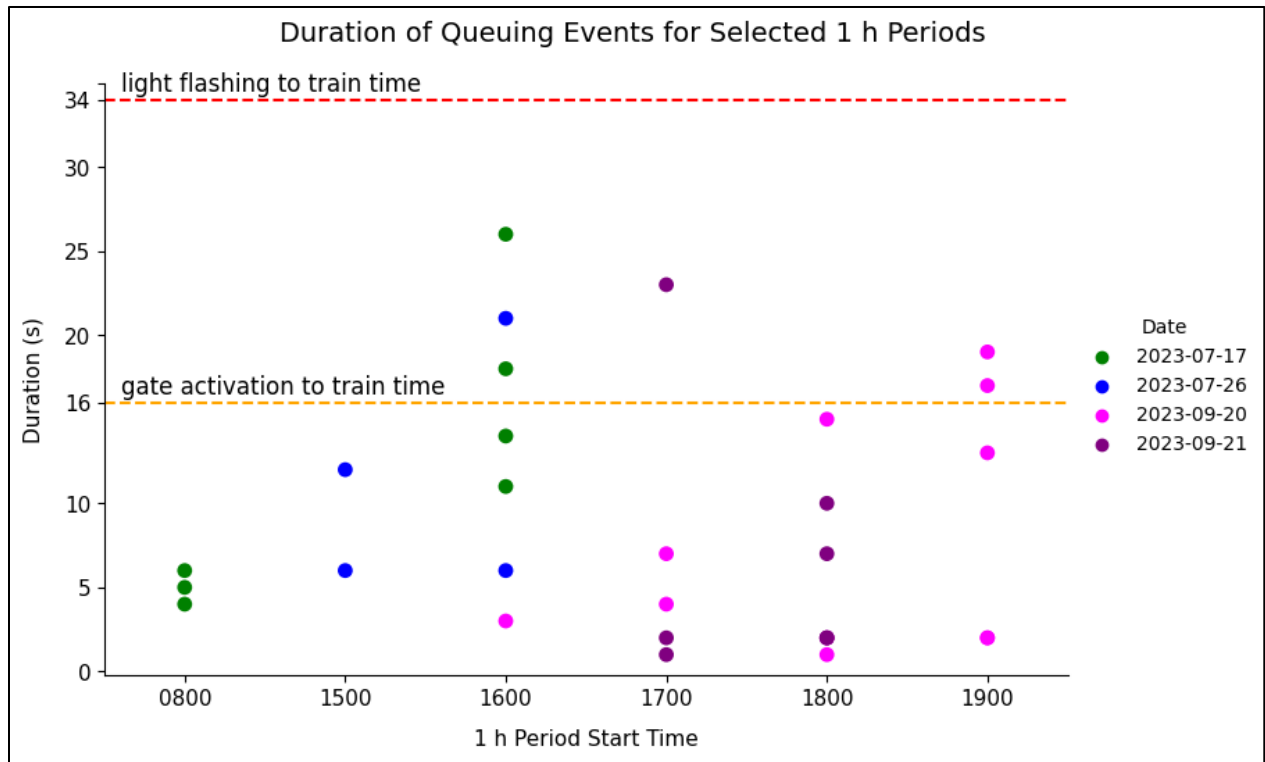
Figure 7: Duration of the queuing events for selected 1 h periods in the dataset. More details about the orange line and red line are provided in the text where this figure is described.

To further investigate into the queuing events, Figure 7 illustrates the queuing durations for selected 1 h periods on the four days the events took place – one in the morning rush hour and five in the afternoon rush hour. As was shown previously in Figure 4, the majority of the queuing events occurred during rush hour commutes, particularly in the afternoon, and so those are the hours shown in Figure 7. For the specific crossing studied in this project, the orange line indicates the time duration from the activation of the crossing arms to the arrival of a train on the crossing surface. The red line indicates the time duration from the activation of the crossing lights/bells to the arrival of a train on the crossing surface.

The 1600 hour (for 1600 up to but excluding 1700) registered the highest number of events, totaling 7. While the average queuing duration stood at 9 s, a significant portion of the events extended beyond 15 s, with the longest lasting up to 26 s.

Given that the time from the activation of the crossing arms until the arrival of a train at the crossing surface was approximately 16 s, and the time from the activation of lights/bells until the arrival of a train at the crossing surface was approximately 34 s for this specific crossing, and considering that the duration of such queuing events was entirely dictated by instantaneous traffic dynamics, it is evident that these events increasingly jeopardize public safety.

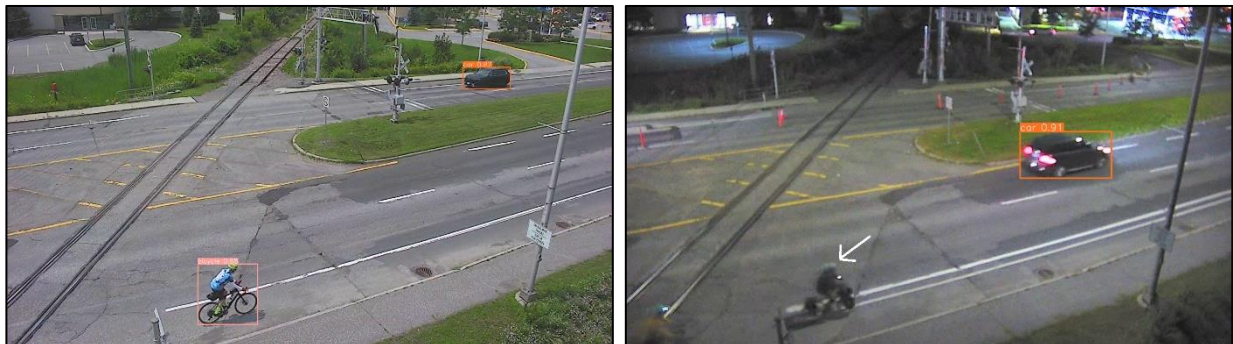
Figure 15: Example detection on day time image (left) and night-time image (right) captured by the PTZ\_ingress camera. The cyclist on the left image captured during the day was accurately detected by the model, while another cyclist in the same position (denoted by the white arrow) captured by the same camera during the night was missed.

The reduced performance during night time could be mainly attributed to the lack of visual features during night time, especially for VRUs which are generally much smaller in size than any vehicles. Another possible reason for the significantly reduced performance during night time could be the poor quality of the night time images from the PTZ cameras. Figure 15 shows two example images captured by the PTZ\_ingress camera. As can be seen, the night time image (right) was blurry and pixelated, essentially diminishing visual features for the cyclist, thus causing a missed detection.

Apart from the blurry and pixelated image issue observed in the PTZ camera images captured during the night time (refer to section 5.1.2 and Figure 15 (right)), there were three other main artifacts noticed in the PTZ camera images. These included the presence of strong shadow, glare, and lens flare which manifested in the form of a reflection of the camera lens itself in the captured images. These artifacts were primarily observed in the third batch of data, likely because the third batch was collected in September when the sun’s angle was different than it was in July, when the other two batches were collected.

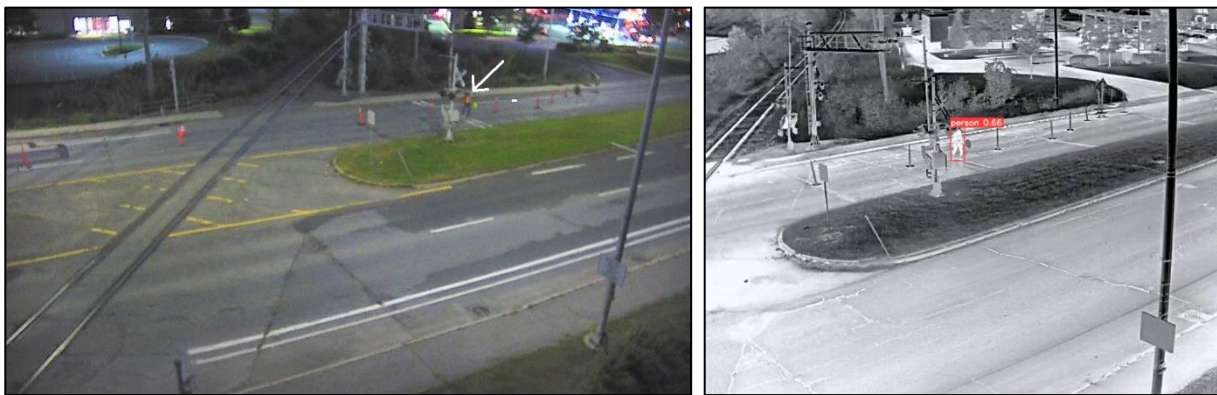
Figure 17: VRU detection during night time on PTZ (left) and thermal (right) camera images. While the model trained on PTZ camera images failed to detect the VRU (denoted by the white arrow on the right image), the model trained on thermal camera images was able to detect it in the corresponding thermal camera image.

Figure 16 shows the results for the same exercise based on thermal camera images. As the precision-recall plots reveal, vehicle and VRU detection performance was comparable across day and night time. This is inline with the expectation since images captured by thermal camera sensors were not affected by lighting variation. Figure 17 shows detection performance on two images captured by the PTZ\_ingress and Thermal\_ingress cameras, respectively. While the VRU blended into the background in the dark in the captured PTZ camera image, the clear thermal signature of the VRU helped it appear bright in the thermal camera image, thereby allowing the model to accurately detect the VRU.

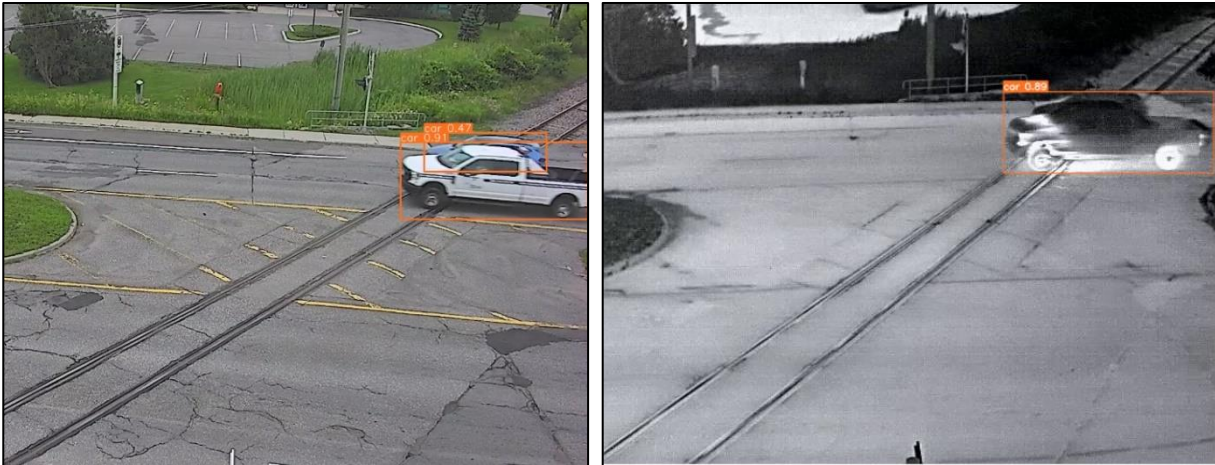
Figure 19: Two occluded cars captured by the PTZ\_egress (left image) and Thermal\_egress (right image) cameras. The model trained on the PTZ camera images was successful in detecting both cars (one in the foreground and a second in the background) as shown in the left image, while the model trained on the thermal camera images failed to detect the occluded car as revealed in the right image.

An example situation based on two images from the high traffic split is illustrated in Figure 19.

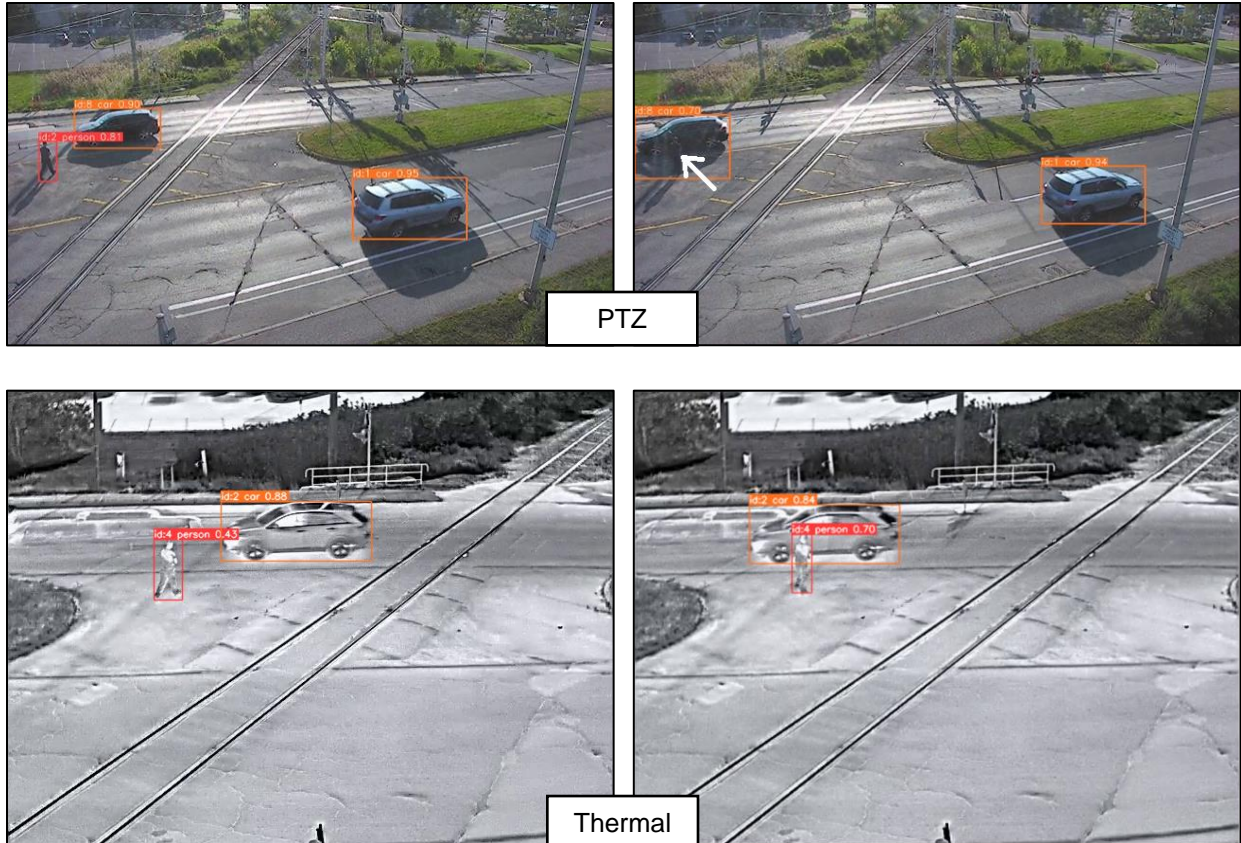
Figure 21: Top row shows detection results on two example images captured by the PTZ\_ingress camera under strong shadow, while the bottom row shows the detection results for the corresponding images captured by the Thermal\_egress camera. In the top-left image, the person was detected accurately until a subsequent frame when the person was completely covered by strong shadow. The missed person due to the passing-car strong shadow that occurred in the next frame sequence (top-right image) is shown by a white arrow. Detection on the thermal camera images remained unaffected by shadow.

The detection performance was observed to decline due to the presence of strong shadows, resulting in both false negatives as well as poor localization of objects. Figure 21 shows examples of detections on images from both the PTZ and thermal cameras under strong shadow conditions. As illustrated in the figure, the VRU in the top-right image went undetected because it was completely covered by strong shadow from a passing car, even though it was detected accurately in the preceding frame sequences. Furthermore, the strong shadow from the car caused the model to incorrectly extend the car's bounding box to include the shadow. In contrast, detections on the corresponding thermal camera images were unaffected.

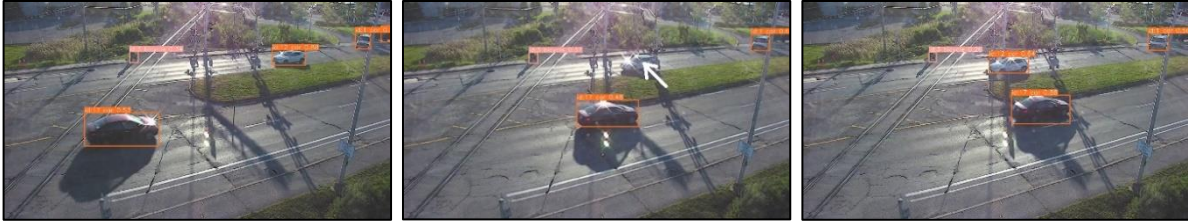
Figure 22: Example of detections on PTZ\_ingress camera images under strong glare conditions; (left image) the white car on the top-right corner of the image travelling along the far lane was accurately detected before entering the glare zone; (middle image) the car was missed in the next frame sequence as it passed through the strong glare zone (denoted by the white arrow); (right image) the car was detected again as it left past the glare zone. (Best viewed when zoomed in.)

Strong glare was another prominent artifact that posed challenges for the model to detect objects from the PTZ camera images, eventually causing missed detections. Figure 22 presents some visualizations of some example detections under strong glare conditions. As the figure illustrates, the glare zone caused the white car travelling on the far lane to go undetected as it passed through that zone (middle image, marked by the white arrow), though it was accurately detected in the preceding and following frame sequences (left and right image, respectively).

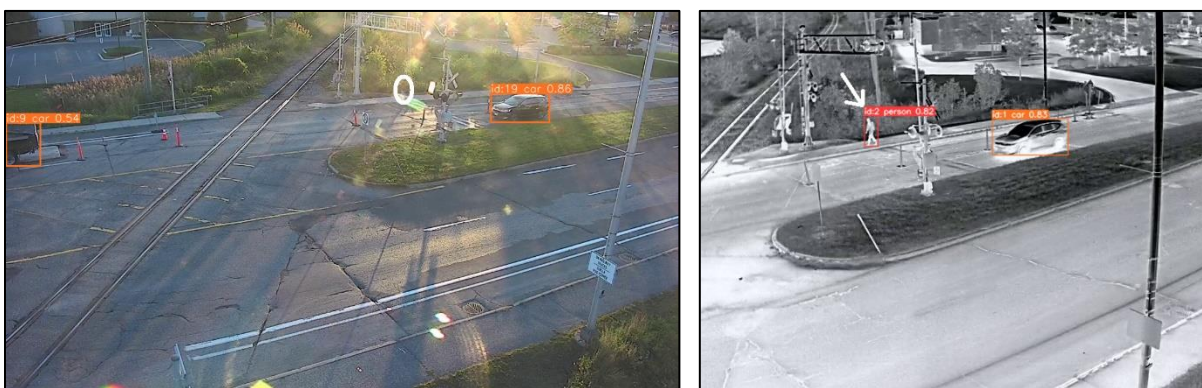
Figure 23: Lens flare causing the pedestrian (encircled in white on the left image) to become completely obscured in the PTZ\_ingress camera image. The corresponding thermal image (right) allowed the model to detect the pedestrian accurately.

Furthermore, the lens flare phenomenon, which occurs when strong light directly hits the camera lens, was frequently observed in the third batch of PTZ camera images. Images affected by lens flare would typically display a bright, often circular or semicircular flare or artifact that originates from the camera lens itself. The result is usually a series of bright spots or a hazy, washed-out area in the image. Detection performance was observed to decline due to the lens flare effect in the PTZ camera images. Figure 23 shows some example detections on one PTZ camera image that was affected by lens flare along with the detections on the corresponding thermal camera image.

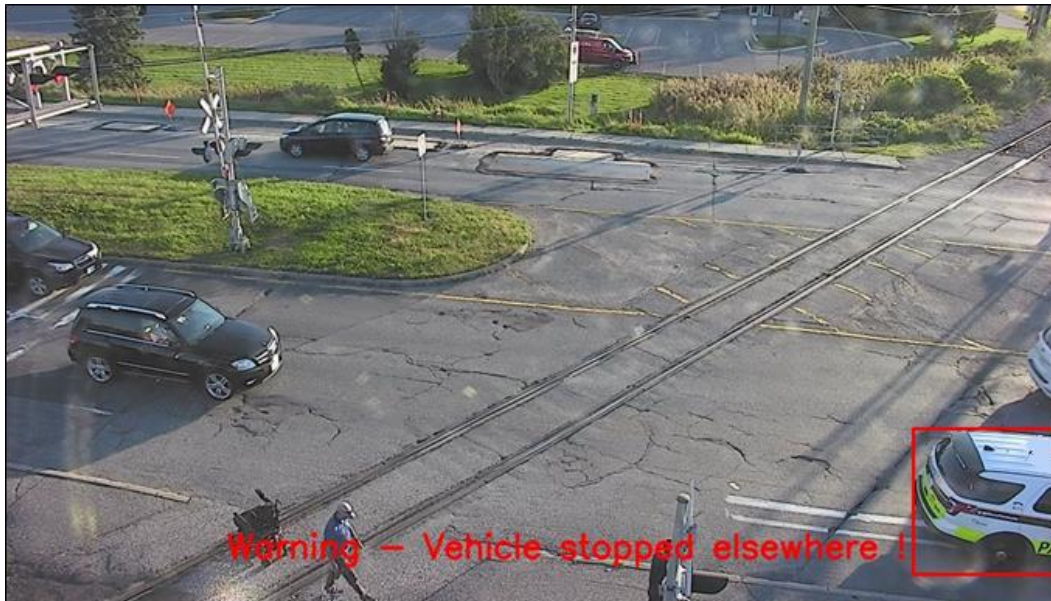
Figure 28: Vehicle (with a red rectangle) detected by the algorithm as stopped elsewhere.

Figure 28 shows a stopped paramedic vehicle detected as stopped elsewhere by the algorithm.

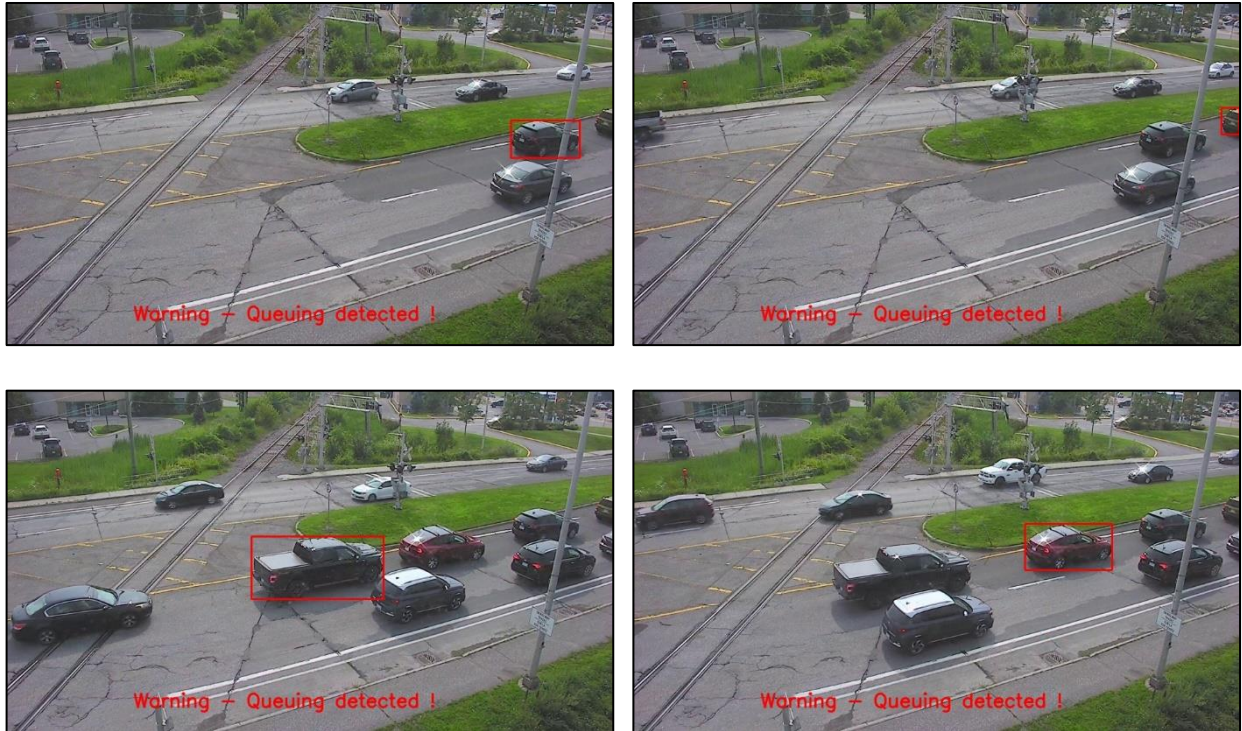
Figure 29: Queuing event involving four vehicles (each with a red rectangle) detected by the algorithm on lane 3.

Figure 29 shows the detection results of a queuing event involving four vehicles located in traffic lane 3 (see Figure 11 in section 4.3.3 for more information on the traffic lanes). The top row in Figure 29 shows that as soon as two vehicles in succession are stopped, the algorithm recognizes that both vehicles (with a red rectangle) are queuing. Even though the stopped vehicles are past the railway tracks themselves, there is a risk that other vehicles may come along later and stop in a place where they block the tracks themselves.

The bottom row shows that other vehicles (each with a red rectangle) joining the queue are also recognized as part of the same queue event.

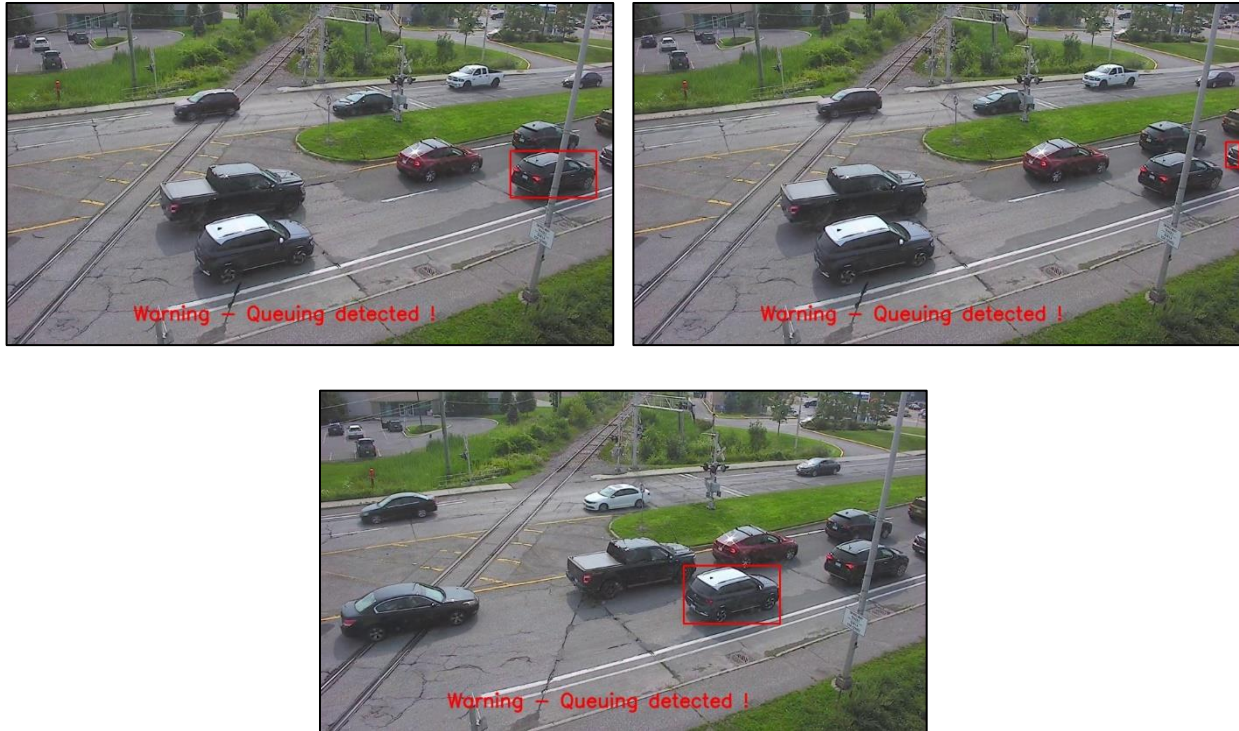
Figure 30: Queuing event involving three vehicles (each with a red rectangle) detected by the algorithm in lane 4.

Figure 30 shows the detection results of a queuing event involving three vehicles located on the fourth traffic lane. In the top row, two stopped vehicles (each with a red rectangle) following one another are identified as queuing. In the bottom row, a third vehicle (with a red rectangle) slowed down and then stopped, and so was recognized as queuing.

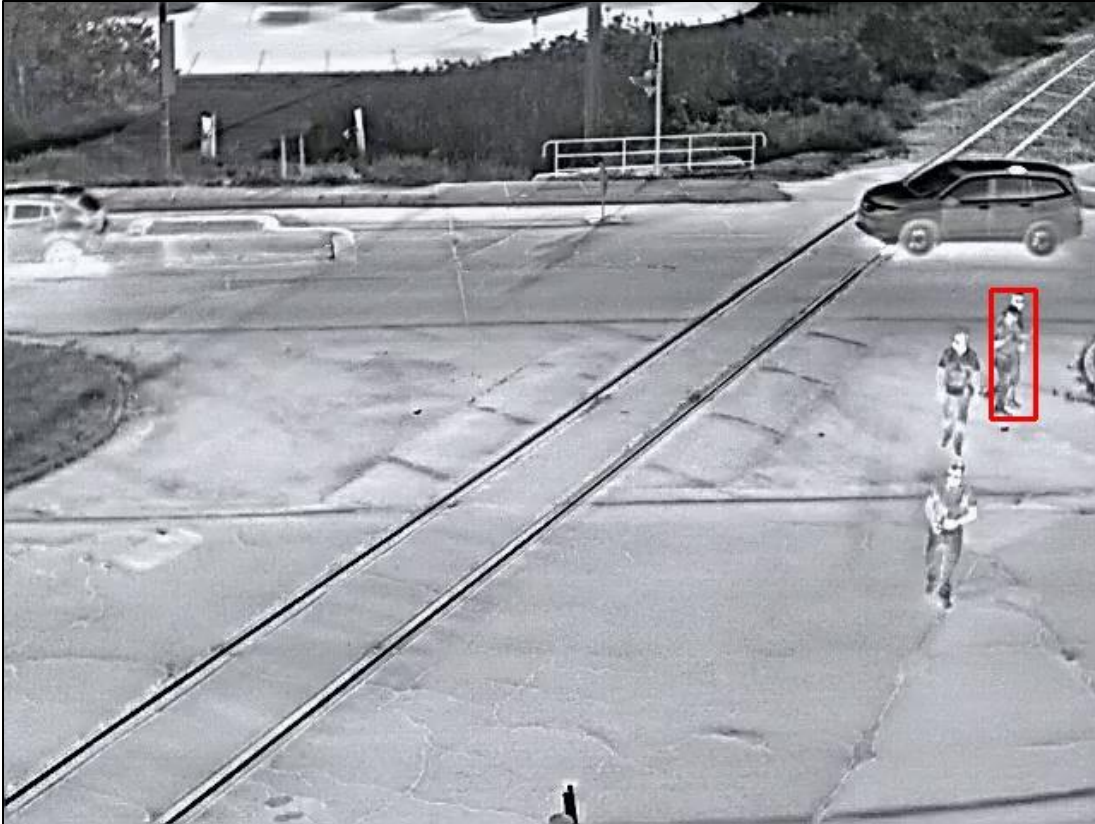
Figure 31: Two pedestrians (with the red rectangle), walking side by side, were detected as one person.

Table 18 presents the results of the jaywalking detection algorithm. The dataset included 29 jaywalking events and the algorithm correctly detected 27 events. The two missing events were not real false negatives because two pedestrians who were walking side by side were detected as a single pedestrian by the detection algorithm. It was expected that the detection algorithm would only recognize the pedestrian facing the camera because the second one would have been hidden by him (see Figure 31). Thus, the jaywalking algorithm only received the trajectory of one pedestrian. Figure 32 shows the detection result of a jaywalking event.

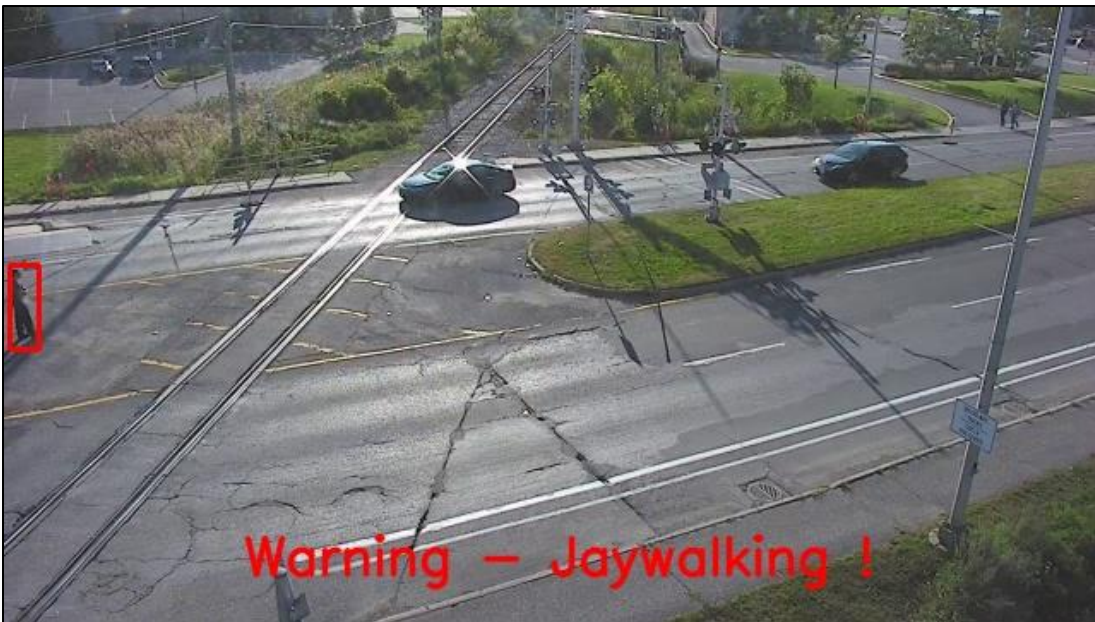
Figure 32: Detection of a jaywalking event.

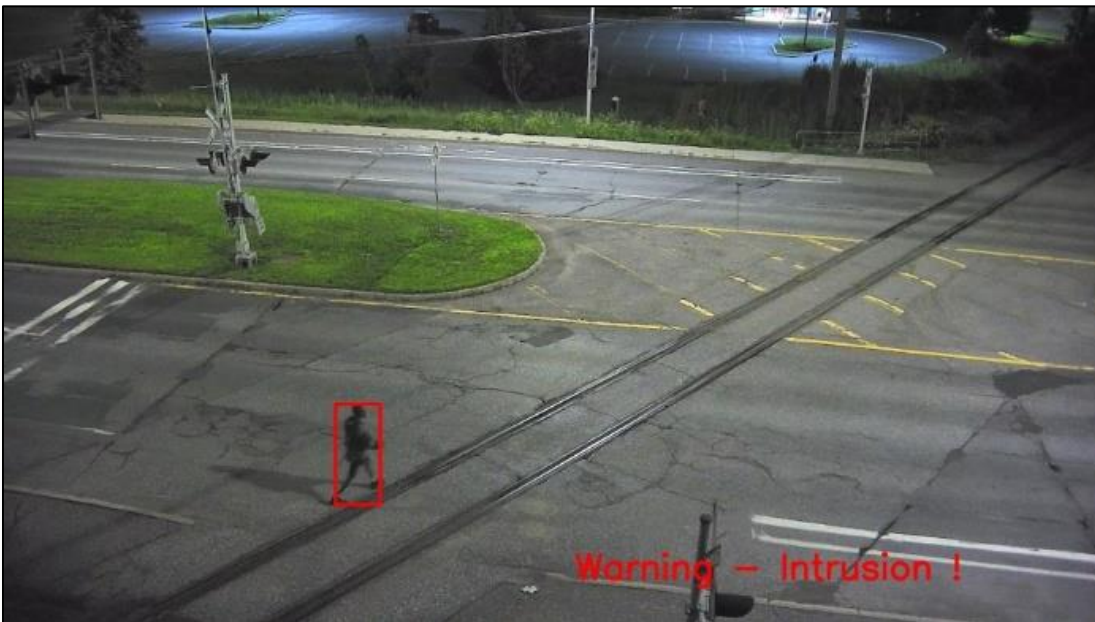
Figure 34: Detection of an intrusion event, a pedestrian crossing the railway track.

Table 19 presents the results of the intrusion detection algorithm. A pedestrian crossing the railway track was recognized by the algorithm as an intrusion event in the danger zone. The dataset included 11 intrusion events and the algorithm correctly detected 10 events. The missing event was not a real false negative because it was related to the same scenario seen in section 5.2.5. Two pedestrians who were walking side by side were detected as one person by the detection algorithm due to the occlusion issue (see Figure 33 for the intrusion example and Figure 31 for the similar jaywalking example). Thus, the intrusion algorithm only received the trajectory of one pedestrian in that event. Figure 34 shows the detection result of an intrusion event.
